## In vivo study of apical cleaning

By Francis W. Allen, DMD, MAGD

Featured in *General Dentistry*, September/October 2007

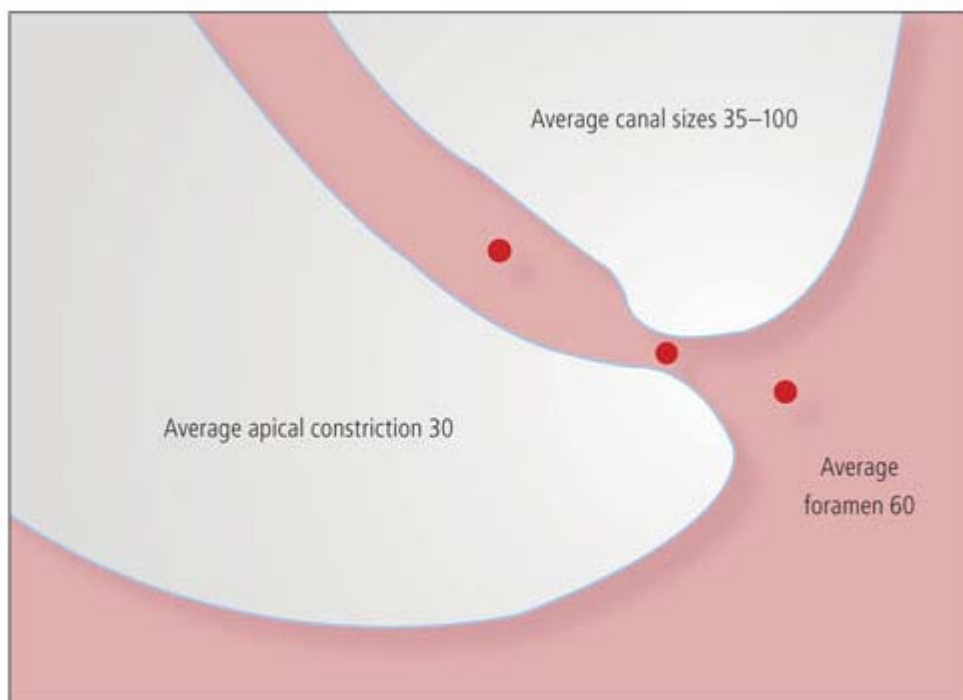
Fig. 1. The terminus of the canal has a large canal, a small apical constriction, and a large foramen.

The canal system terminates in an apical constriction that is similar to an hourglass (Fig. 1). Back in 1955, Kuttler reported the average foramen was 0.60 mm and the average apical constriction was 0.30 mm.<sup>9</sup> Behind the constriction, the actual canal sizes averaged 0.35–1.00 mm.<sup>3-5,10-14</sup>

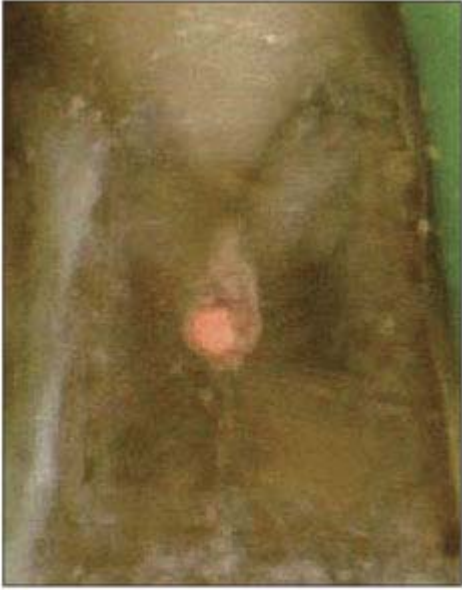
Fig. 3. An example of a grossly underprepared canal with residual debris all around the gutta-percha.

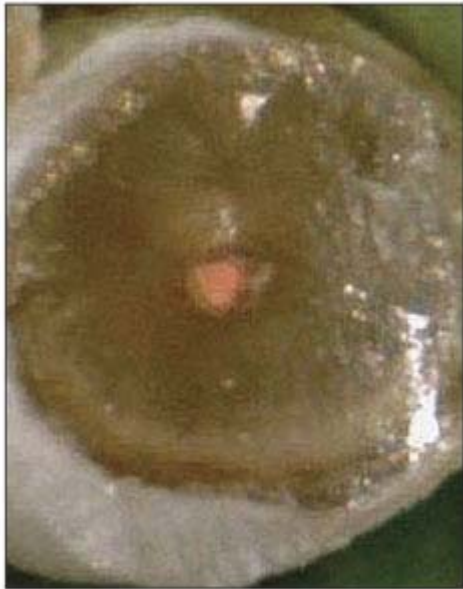
Fig. 4. An inadequately cleaned canal with residual debris all around the more centered gutta-percha. It probably was prematurely apically gauged on the tangent of the canal's curves.

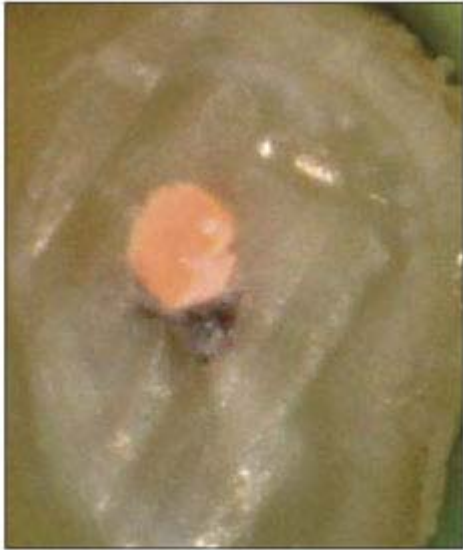
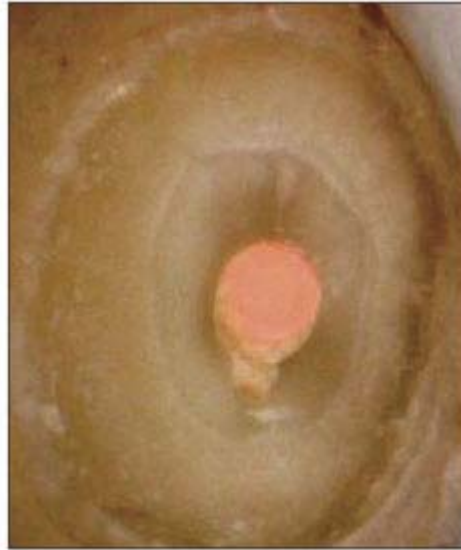
Fig. 7 and 8. A canal transported out one end of its oval, leaving residual debris in the center of the canal; the debris was not removed with irrigation or entombed with obturation.

All 16 canals (100%) that were instrumented to a round shape, to the larger diameter of their oval, had no residual debris (Fig. 5). Of the 91 canals that were not instrumented to a round shape, only three were without debris (Fig. 6). Of the 88 canals with residual debris, 42 (48%) were transported (Fig. 7). The teeth in Figures 7–10 probably would have been cleaned adequately if the stiffer instruments had not transported out of the canal.

For 82% of the evaluated canals, apical gauging resulted in inadequate enlargement and debris removal at 1.0 mm from the apical constriction. Tapered instruments also caused a 48% transportation rate 1.0 mm from the apical constriction (Fig. 7).

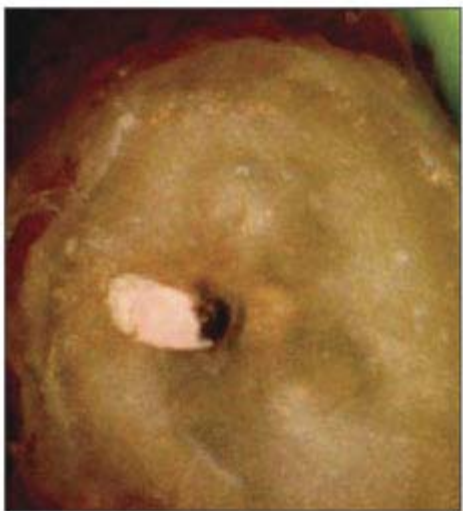
Fig. 9. Debris is transported so far out of the canal with a stiff tapered instrument that there is almost a perforation out the side of the tooth. Sealer filled in the outer part of the transportation, with gutta-percha filling the middle of the "new" canal while leaving debris in the original canal.

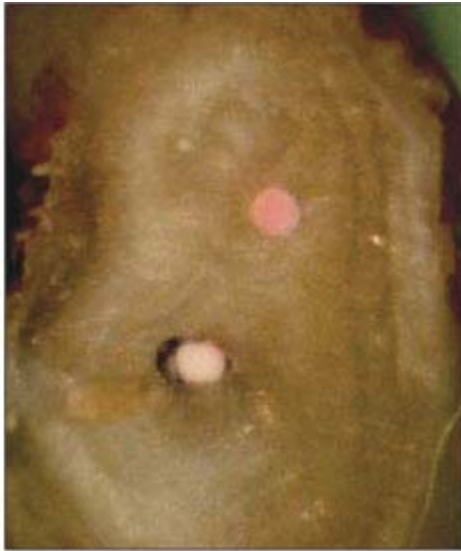
Fig. 12. Apical gauging of the mesiobuccal canal resulted in a canal without residual debris. Apical gauging of the mesiolingual canal bound in the narrower diameter of the oval canal and resulted in debris on both sides of the gutta-percha. Irrigants did not remove the debris 1.0 mm from the apical constriction, nor did the gutta-percha or sealer entomb the residual debris to prevent leakage.

The oval shape of the canal is the second obstruction to effective apical gauging.<sup>4,6</sup> If the apical gauging hand file and step-back file make it to working length without binding in a curve, the file binds in the narrower dimension of the oval canal (Fig. 12).
